# Harrison Elem. Weekly Blitz: May 8<sup>th</sup>, 2020

# Crosby Elem. Weekly Blitz: May 8<sup>th</sup>, 2020

# Miami Whitewater Weekly Blitz: May 8<sup>th</sup>, 2020

# Junior High Weekly Blitz: May 8<sup>th</sup>, 2020

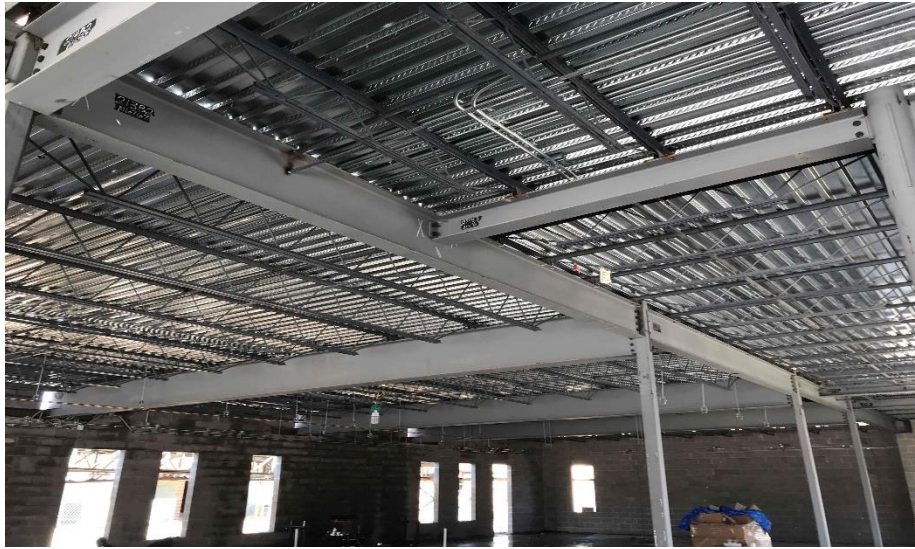
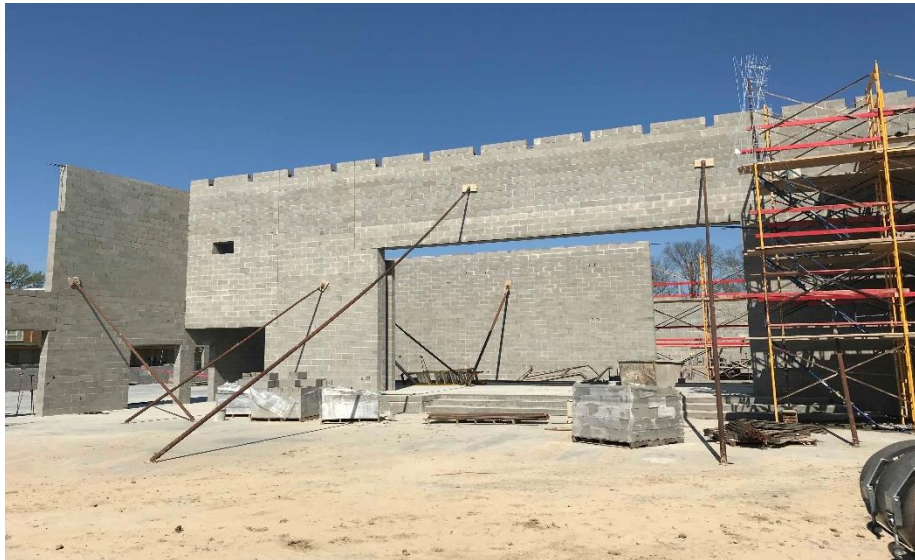
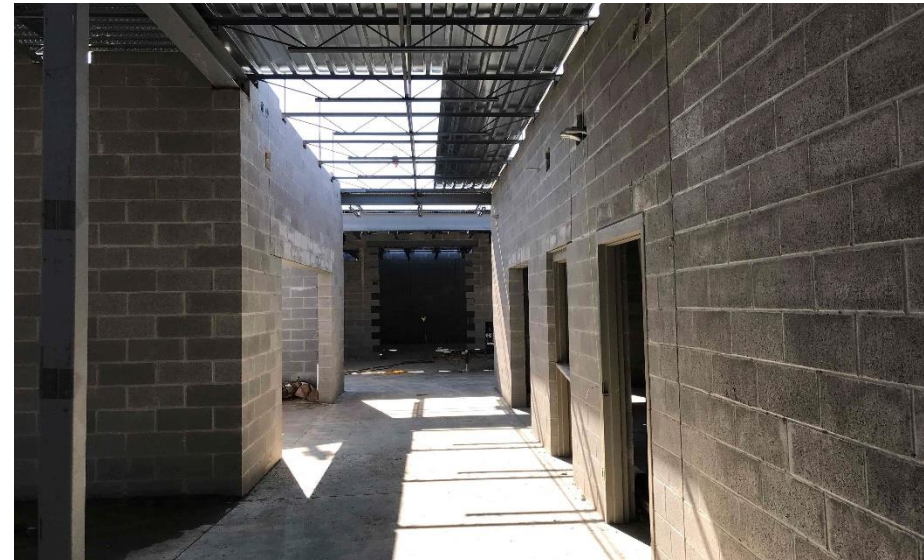
**Harrison Elementary:** The gym, mechanical, and kitchen bearing walls continue to rise in Area A. In Area B, steel columns and beams are being set in the South half of the 2<sup>nd</sup> floor while the metal decking gets installed in the North half. Electrical and plumbing rough-ins are being installed in bearing block.

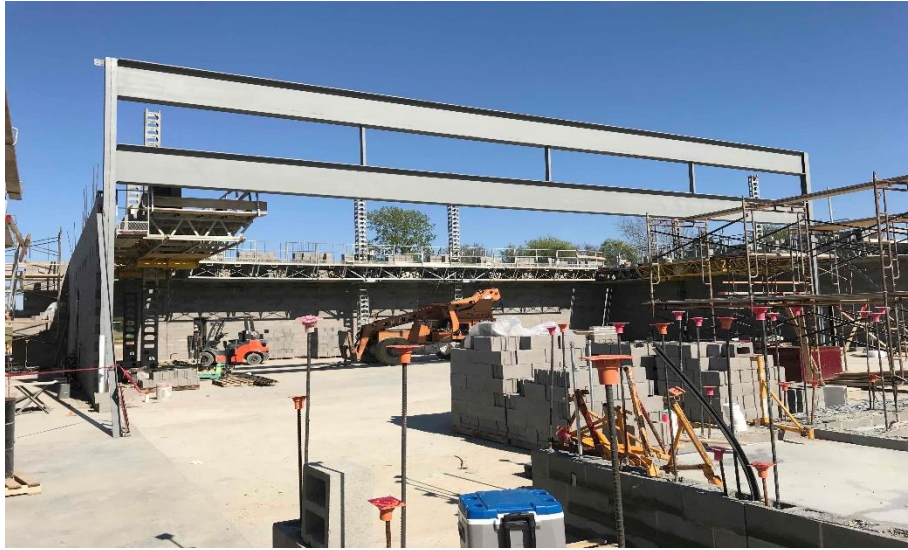
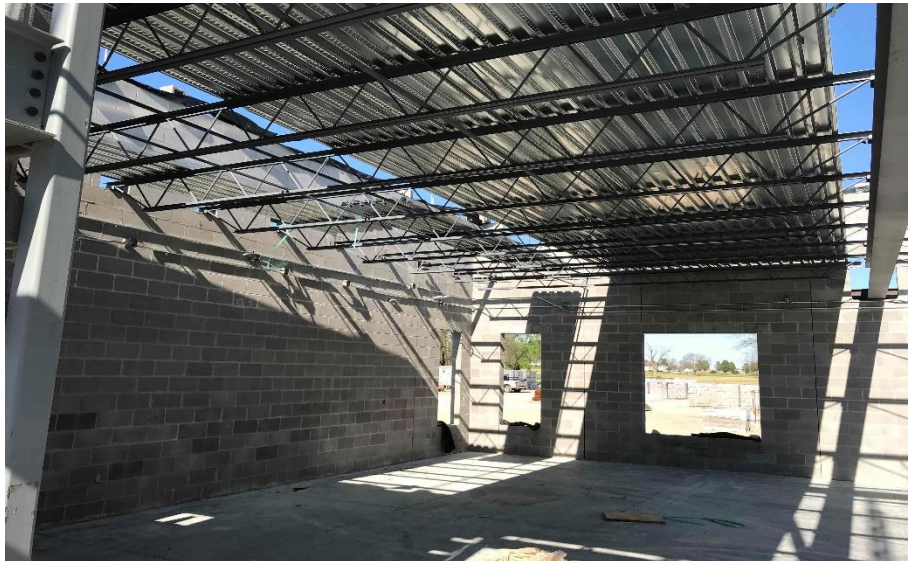
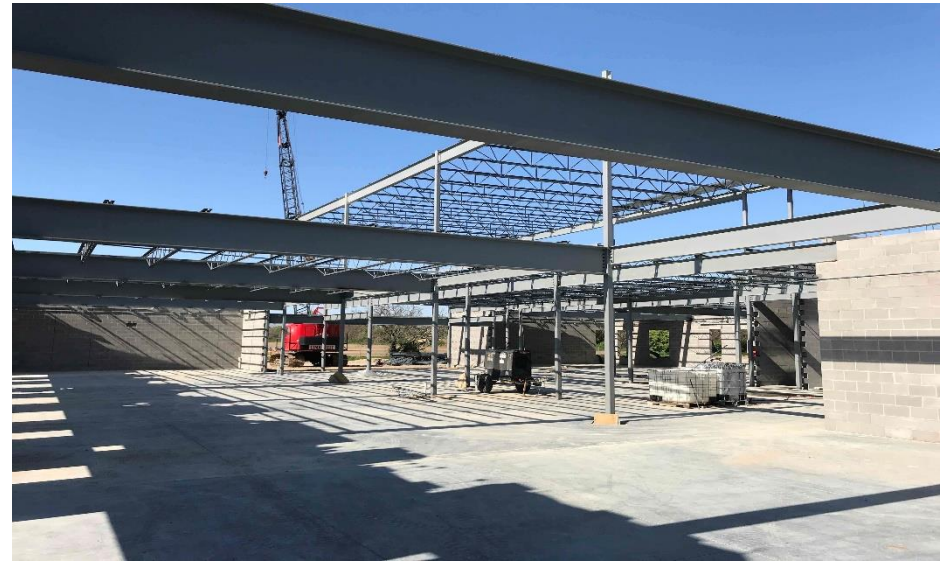
**Crosby Elementary:** Bearing walls in the gym and the cafeteria continue to rise in Area A. In the North half of Area B, steel column baseplates are being grouted and steel connections are being detailed while metal decking follows closely behind. Electrical and plumbing rough-ins are being installed in bearing block.

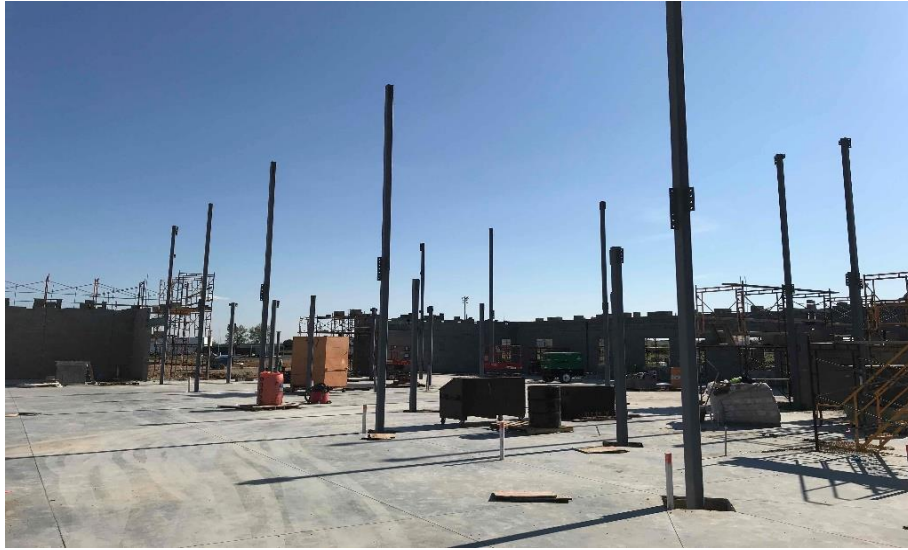
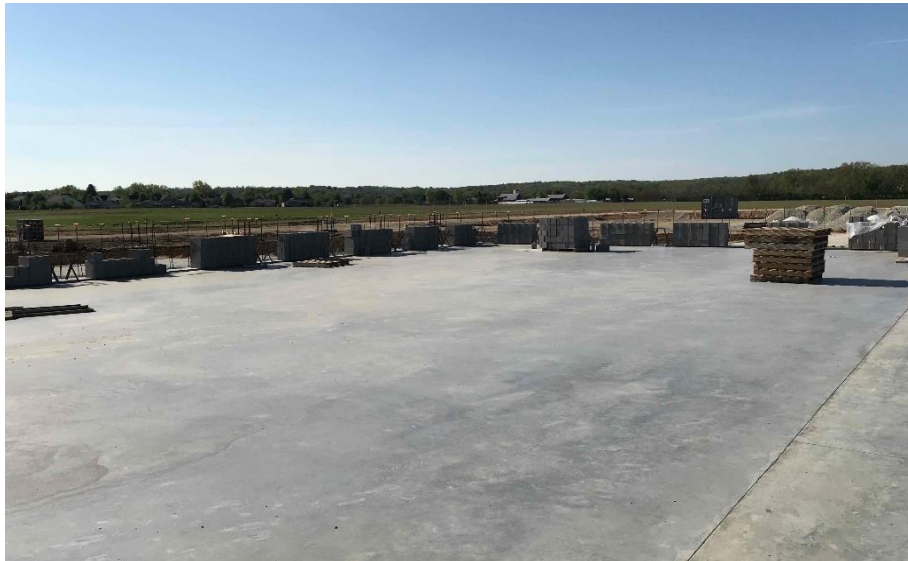
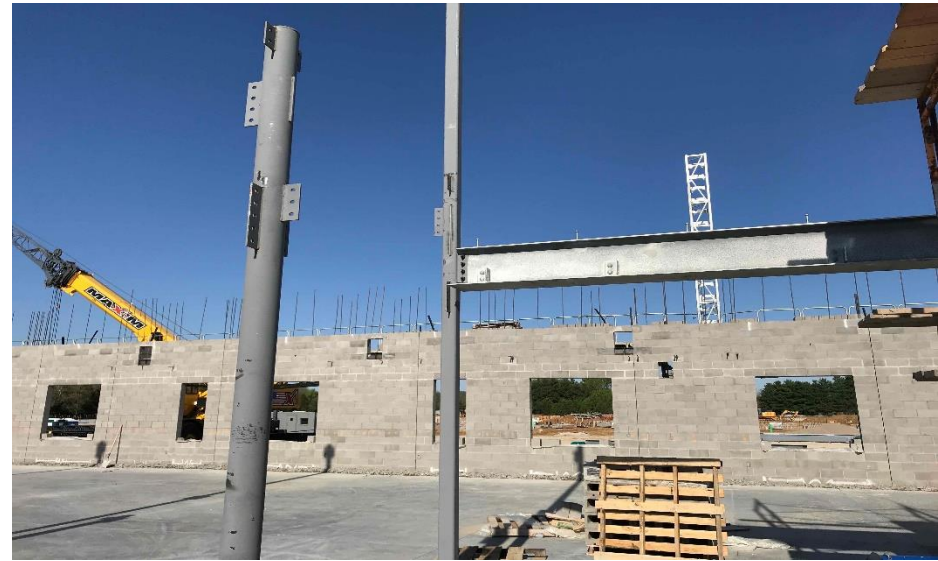
**Miami Whitewater Campus:** Bearing walls in Area B continue to rise in preparation for the 2<sup>nd</sup> floor steel. The steel columns and beams in the South half of Area B are being set. Electrical and plumbing rough-ins continue in Area B.

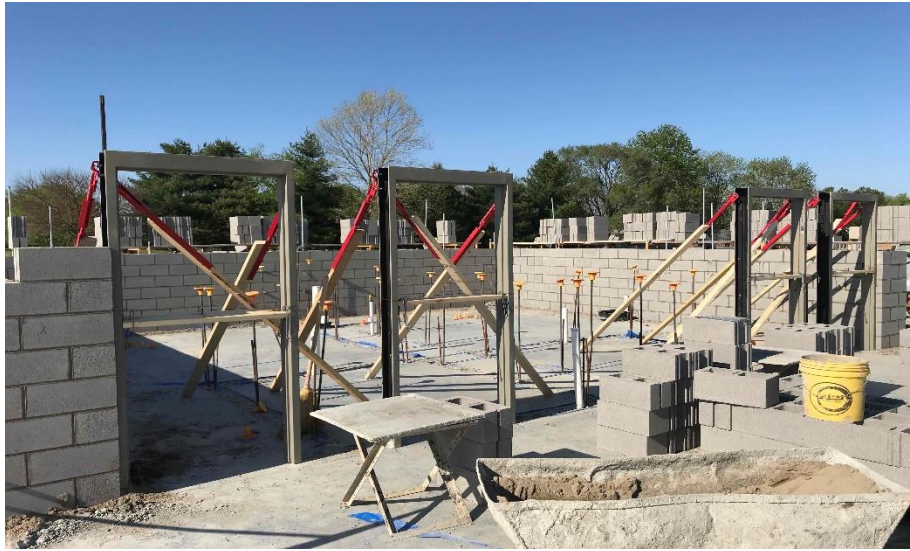
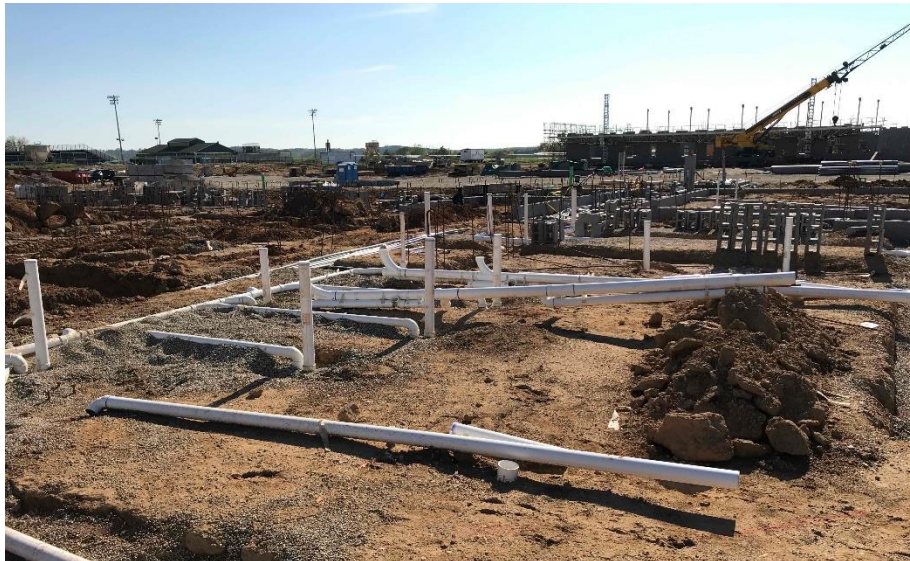
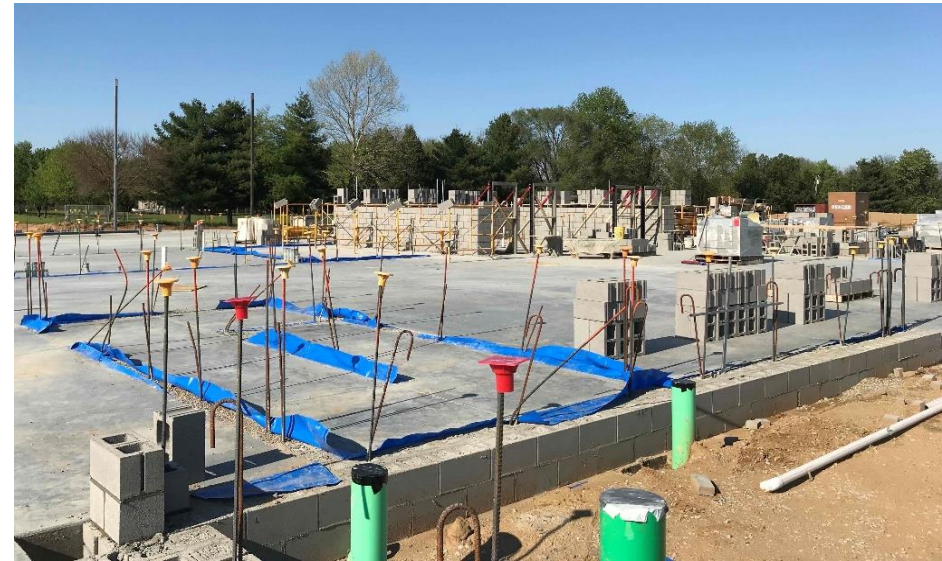
**Harrison Junior High:** The concrete footers have been completed as foundation block moves from Area B to Area C. Bearing walls have started at the restroom core in Area A while Area B is being prepped for the slab on grade. Underground electric has been installed in Area B and the underground plumbing continues in the kitchen.
