Harrison Elem. Weekly Blitz: August 28th, 2020

Crosby Elem. Weekly Blitz: August 28th, 2020

Miami Whitewater Weekly Blitz: August 28th, 2020

Junior High Weekly Blitz: August 28th, 2020

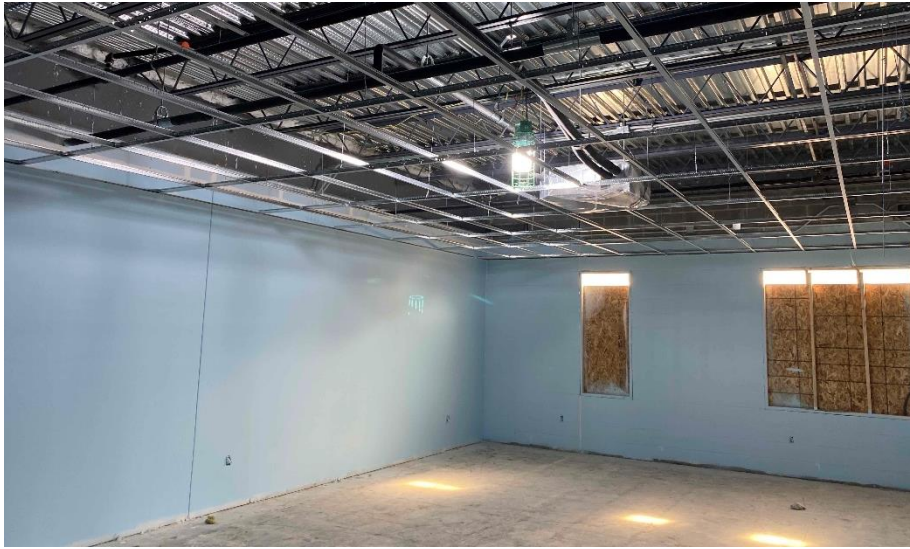
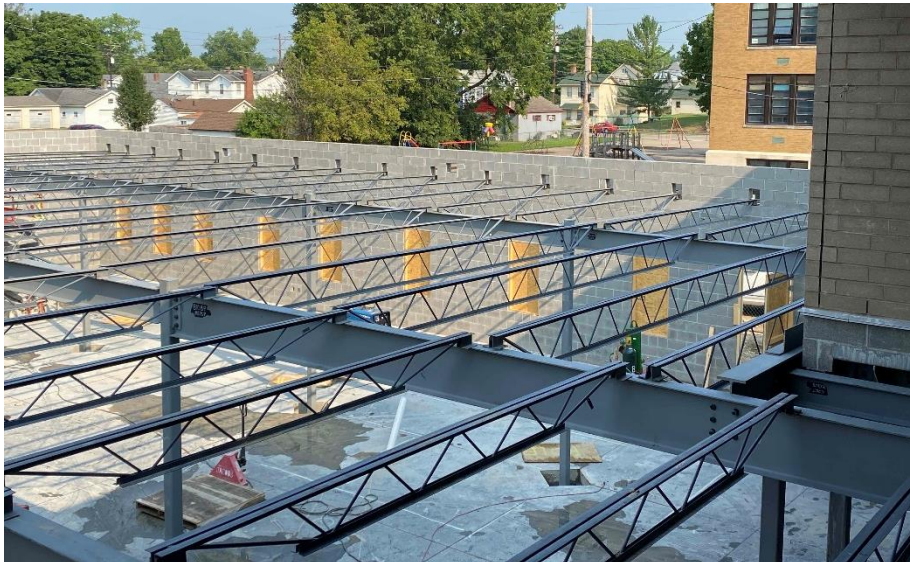
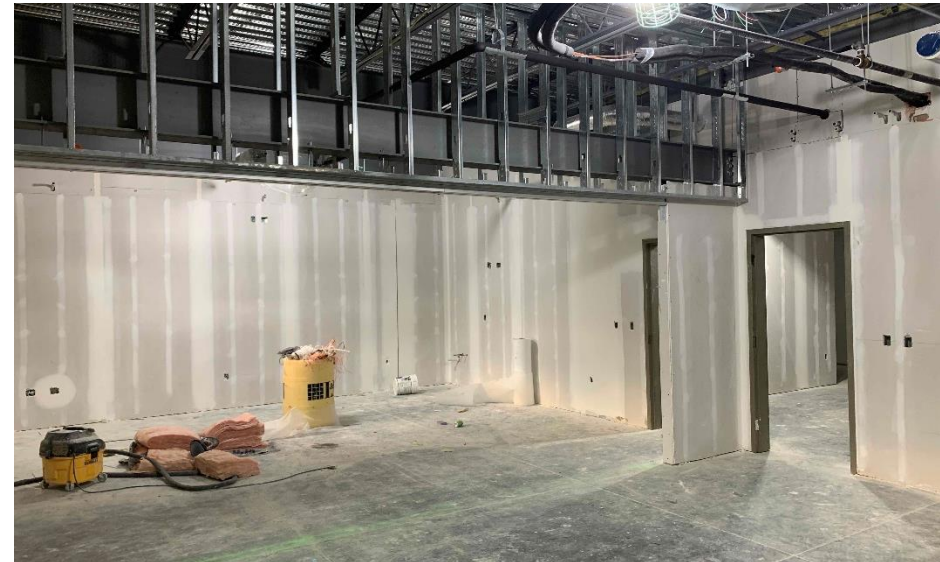
Harrison Elementary: In Area A, structural steel is being erected in the art room and administration area while the roof over the kitchen and mechanical room has been installed. In the academic wing, the 1st floor walls are being painted followed by ceiling grid installation while drywall is being hung and finished on the 2nd floor. Brick is being laid in the courtyard between Areas A and B.

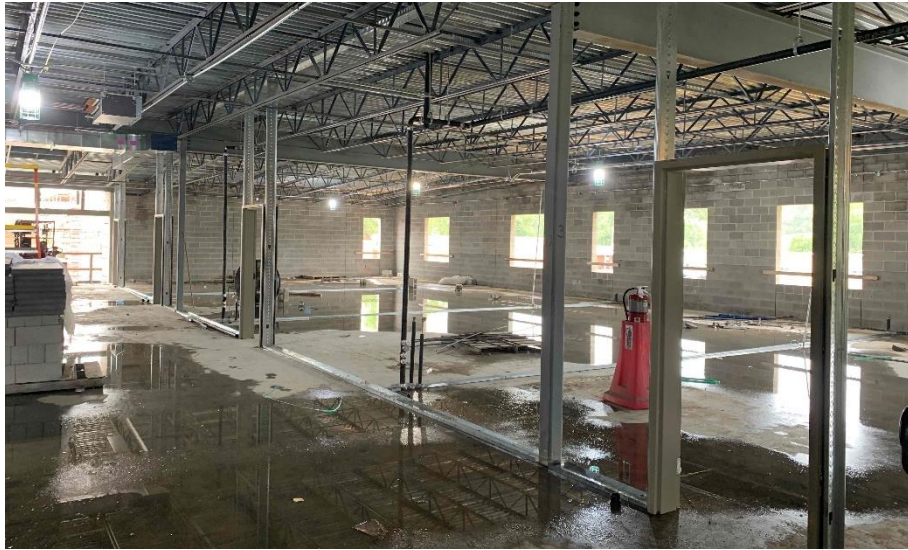
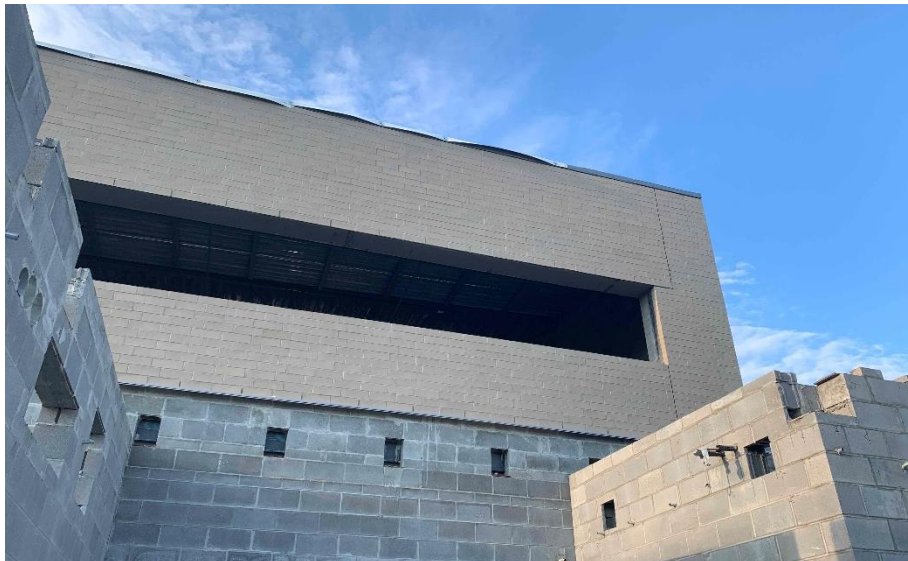
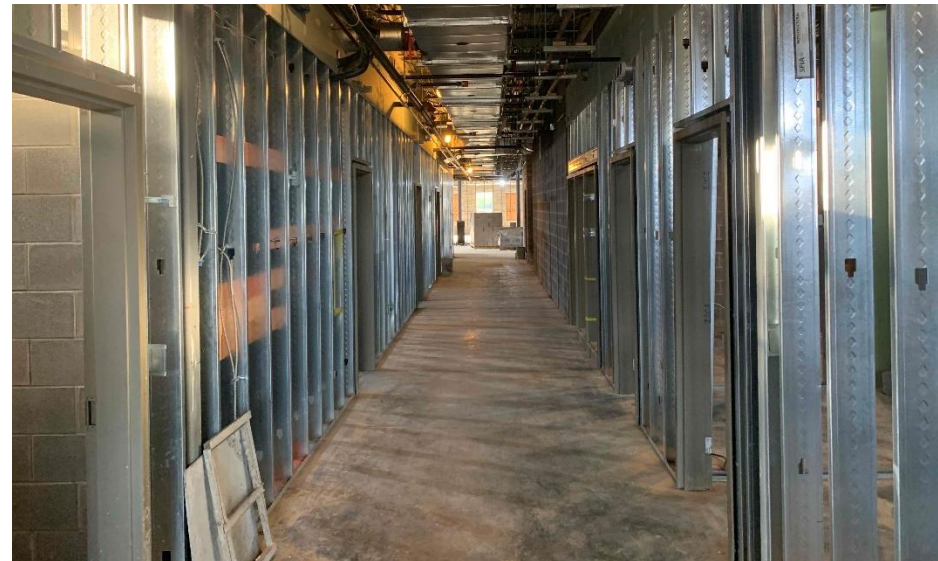
Crosby Elementary: In Area A, the art room bearing block walls will be completed this week while the kitchen is being prepped for structural steel. Roofing installation and the 2nd floor interior wall framing began this week in the academic wing. In-wall and above ceiling MEP rough-in continues in both Areas.

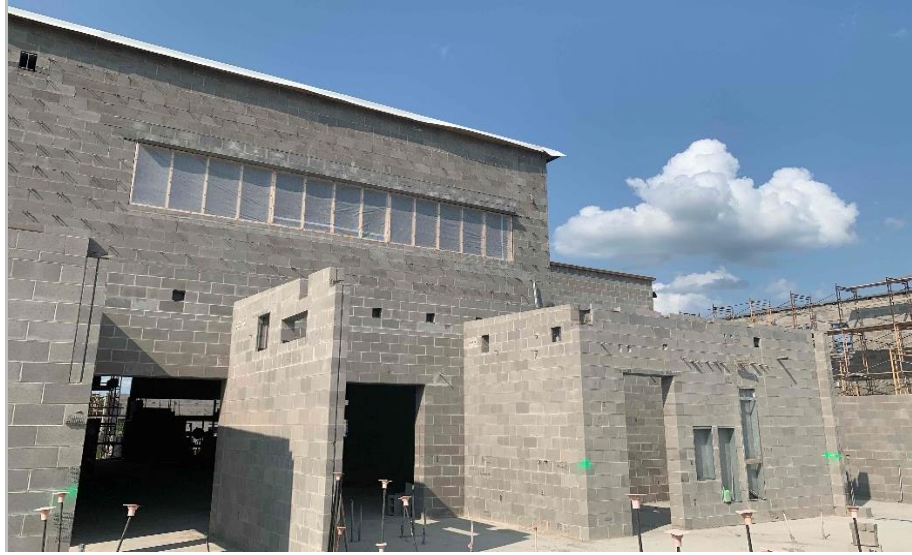
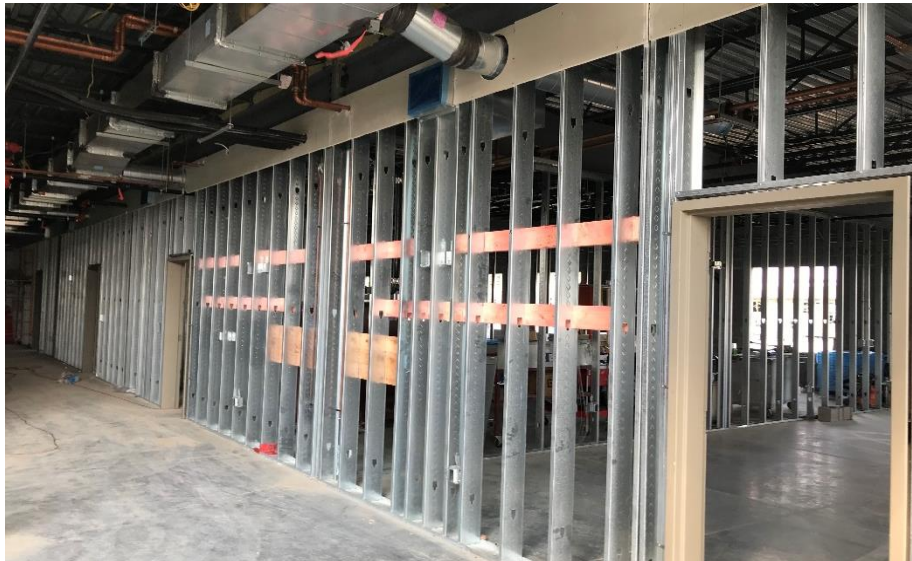
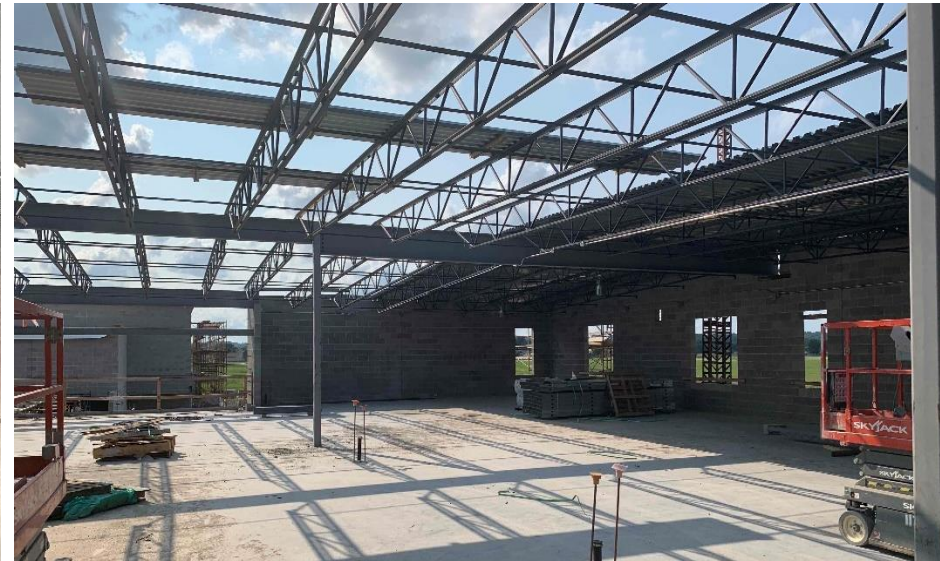
Miami Whitewater Elementary: Bearing block walls are being laid in the kitchen, mechanical room, and administration area in Area A. In Area B, structural steel for the roof is being set in the North half of the 2nd floor while the roof is being installed in the South half. The interior walls on the 2nd floor are being laid out. In-wall and above ceiling MEP rough-in continues throughout Area B.

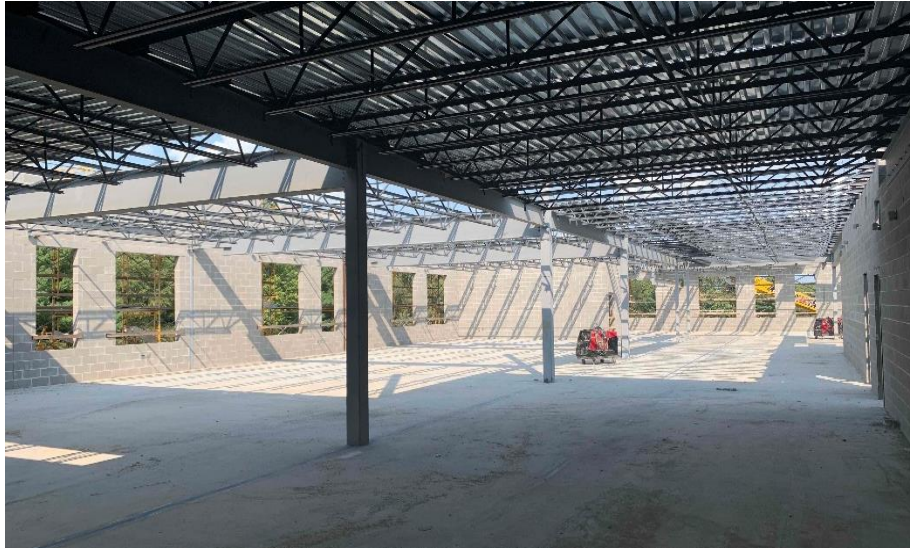
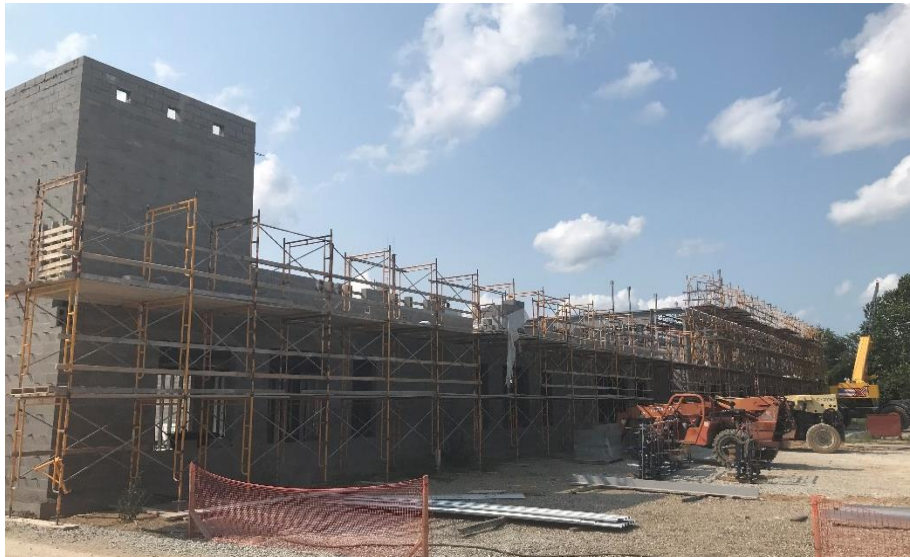
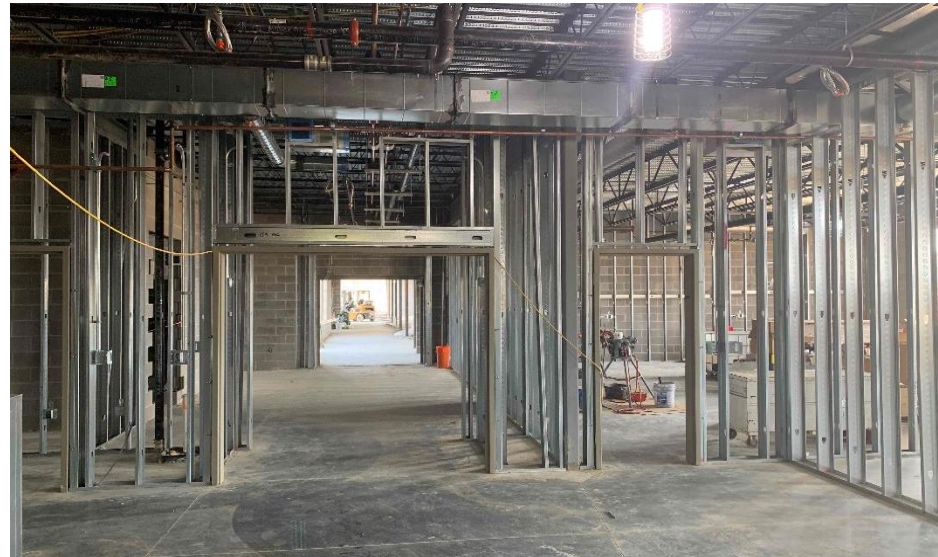
Harrison Junior High: In the academic wing, structural steel is being erected in the East half of the 2nd floor. The concrete slab for the 3rd floor is scheduled to be poured next week which will complete all building concrete work for the 4 schools. The Area B interior walls are being laid out and framed on the 1st floor and the Area C bearing block walls continue to rise in the kitchen.
