Harrison Elem. Weekly Blitz: September 4th, 2020

Crosby Elem. Weekly Blitz: September 4th, 2020

Miami Whitewater Weekly Blitz: September 4th, 2020

Junior High Weekly Blitz: September 4th, 2020

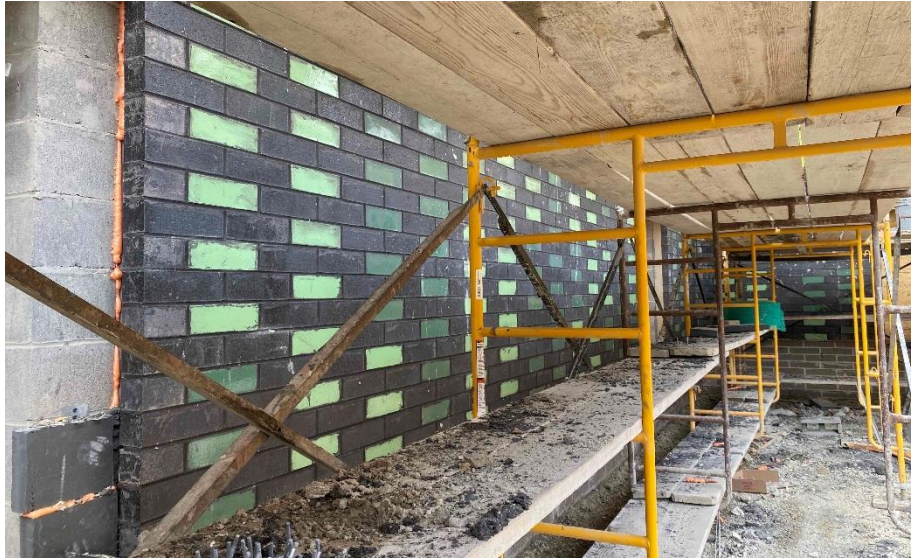
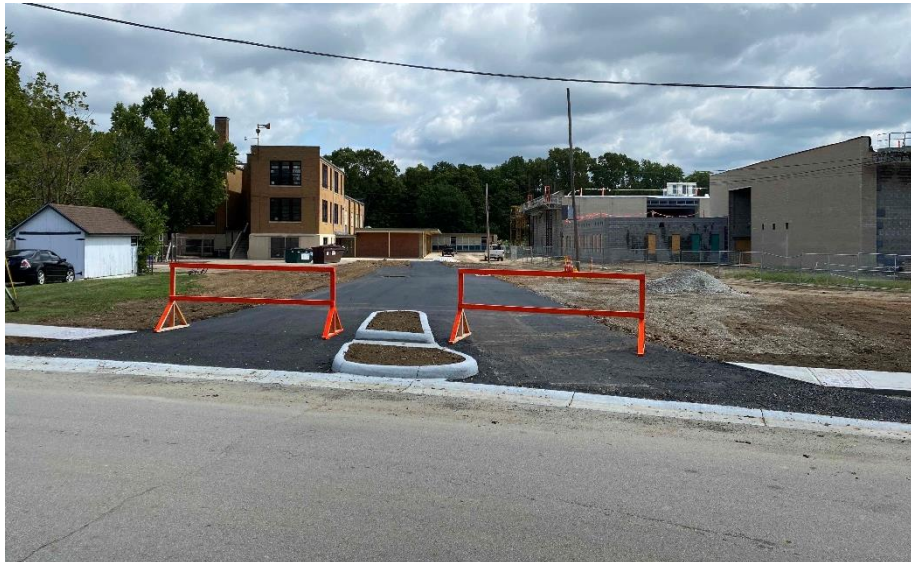
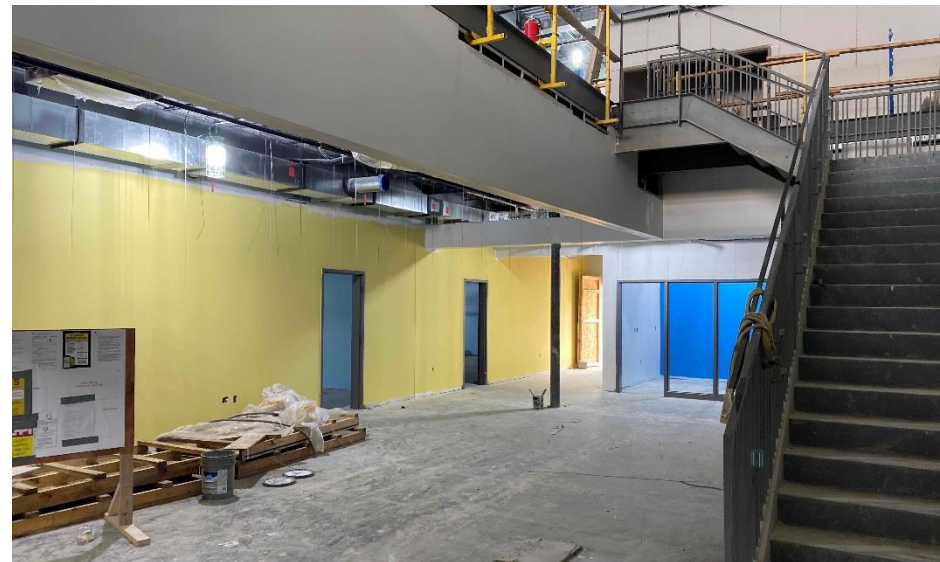
Harrison Elementary: In Area A, structural steel is being erected in the art room and administration area. In the Area B academic wing, the 1st floor walls are being painted followed by ceiling grid installation while drywall is being finished on the 2nd floor. Brick is being laid in the courtyard between Areas A and B and at the South wall of the kitchen. Above ceiling MEP rough-in continues in both Areas.

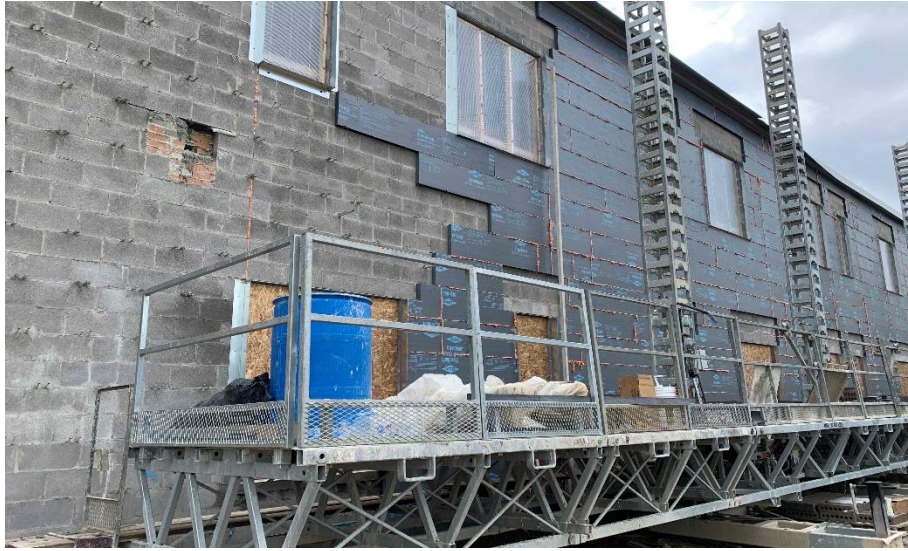
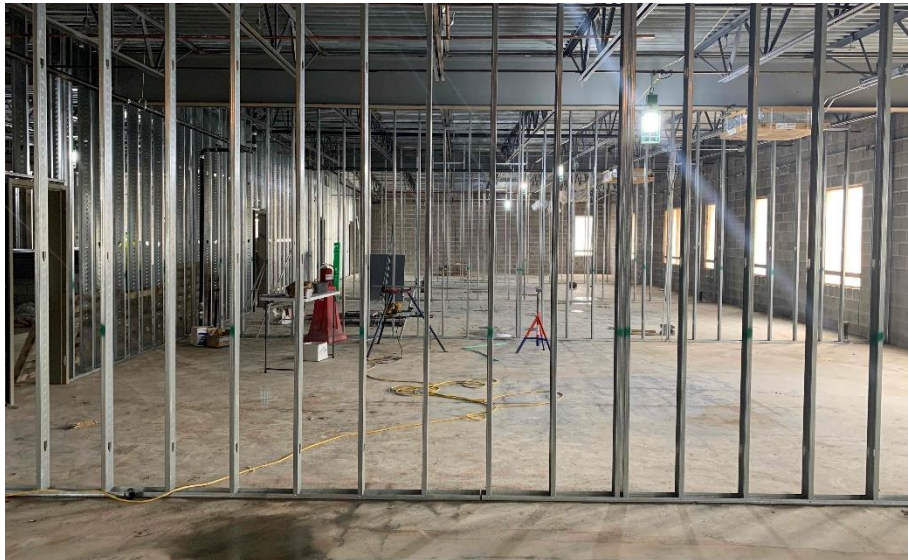
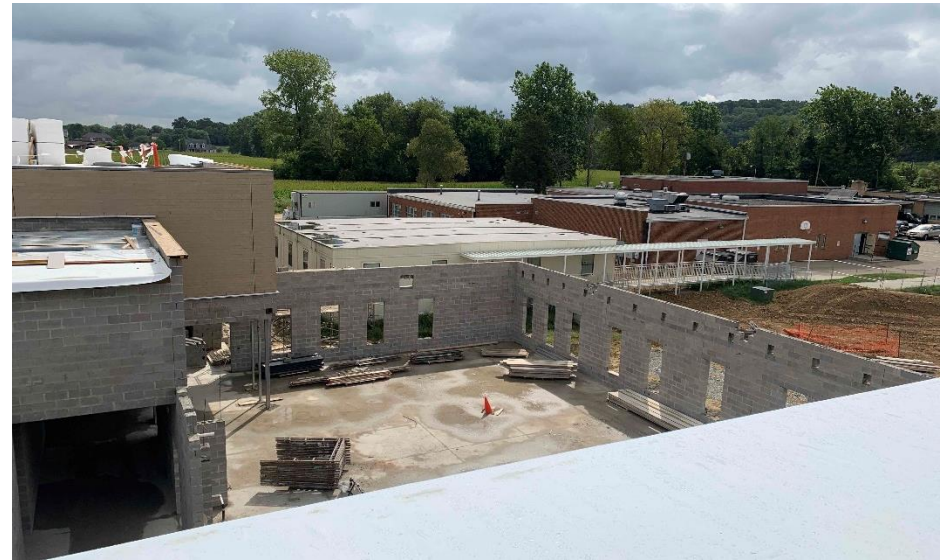
Crosby Elementary: Steel roof joists and decking are being installed in the kitchen in Area A. In Area B, the 2nd floor interior walls have been framed in the academic wing. Interior CMU block walls are being laid on level 2 while brick is being laid at level 1. In-wall and above ceiling MEP rough-in continues in both Areas.

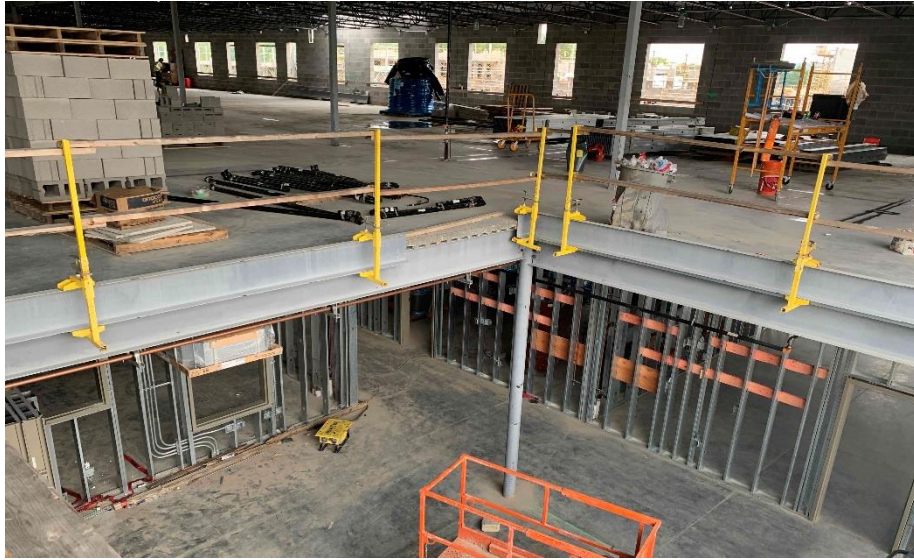
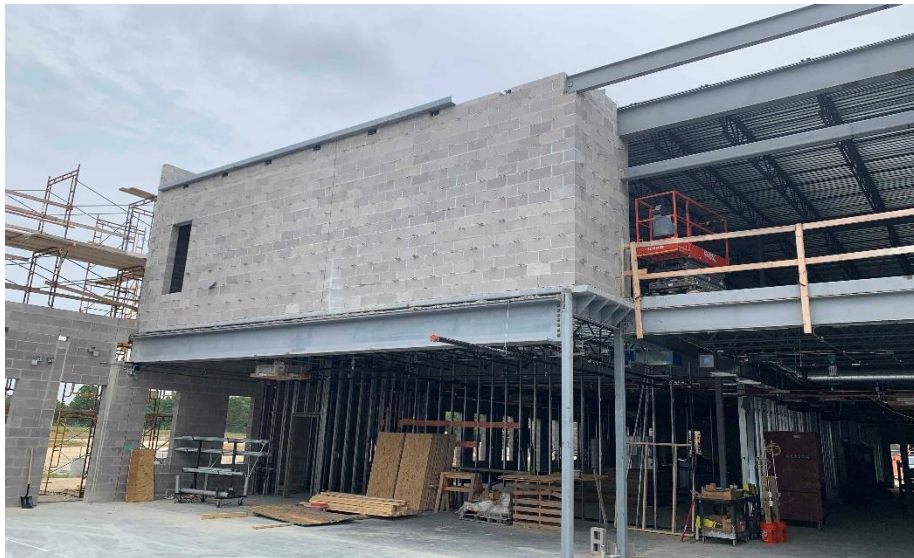
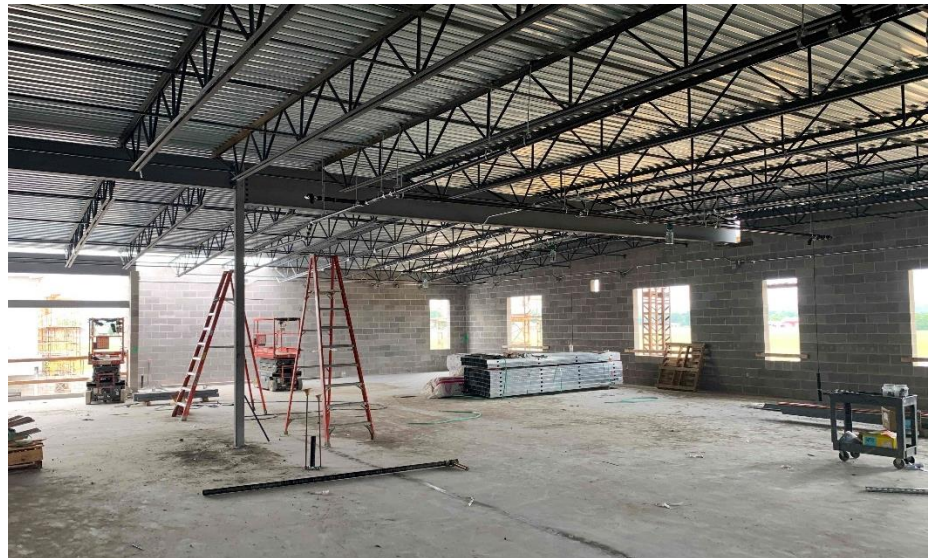
Miami Whitewater Elementary: Bearing block walls are being laid in the kitchen, mechanical room, and administration area in Area A. In Area B, structural steel roof decking is complete as roof installation continues. The interior walls on the 2nd floor are being laid out. In-wall and above ceiling MEP rough-in continues throughout Area B.

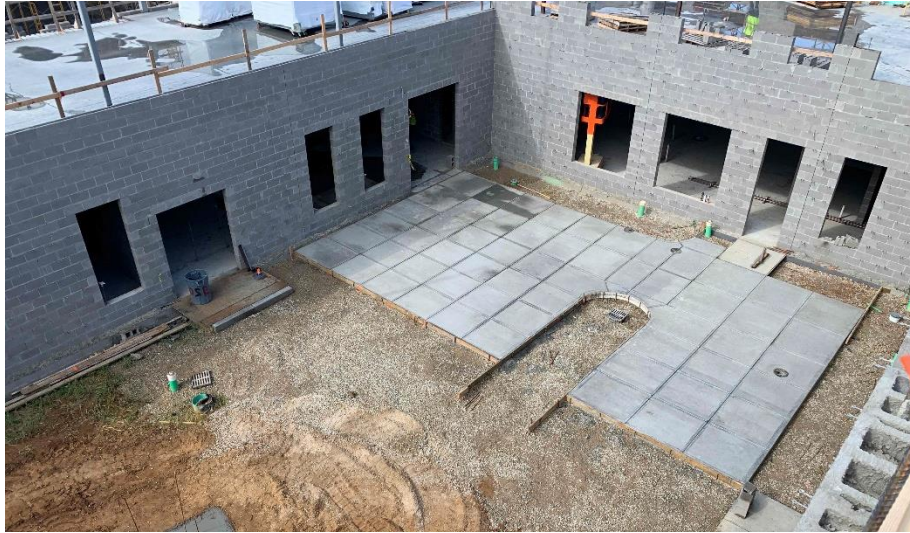
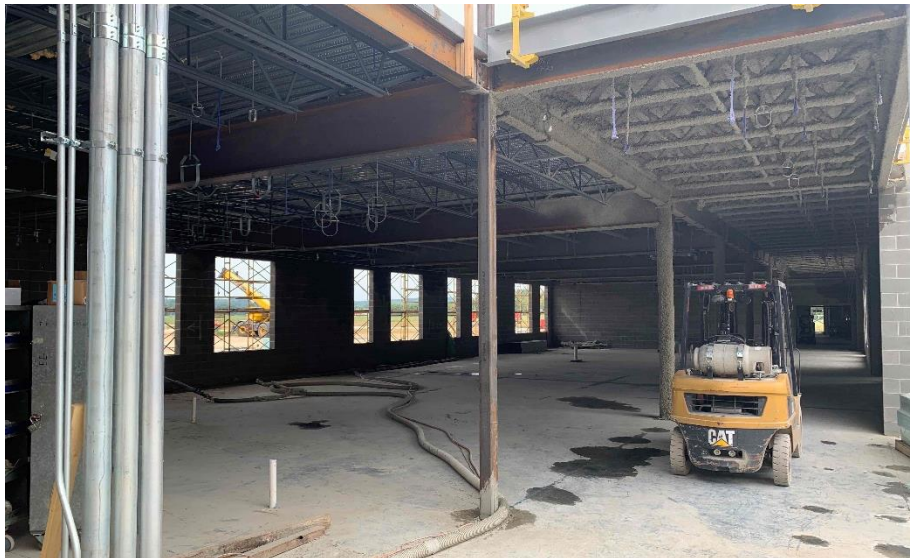
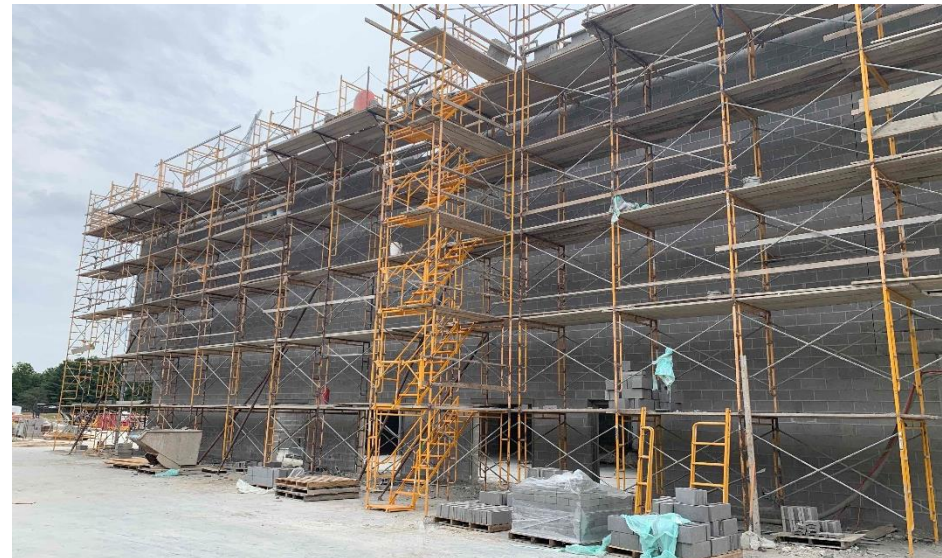
Harrison Junior High: In the academic wing, structural steel has been set and completed on the 2nd floor. The concrete slab for the 3rd floor is scheduled to be poured next week which will complete all building concrete work for the 4 schools. Bearing block walls continue to rise in Areas B & C and concrete has been poured in the courtyard. In-wall and above ceiling MEP rough-in continues in both Areas.
